Introducing reinforced pumice concrete IPS vertical enclosure for low-cost housing projects

Biniyam Shewamare

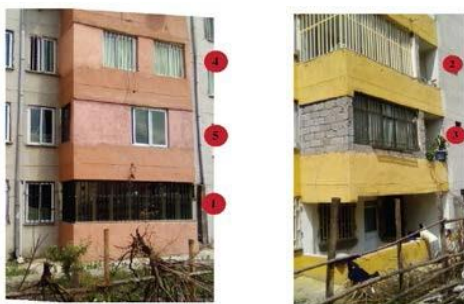
Fig 4.6 Balcony engulfed to the interior

Unforeseen modification on the facade has two visible problems. The first one is aesthetics while the other is technical. Saying aesthetics, it is to say unevenness of masonry work with the existing one. There is also nonuniformity of material type and uneven color harmony with the story above. The technical problem that is observed here is an undetermined additional load. This shortens lifetime of the construction work. In the sample sites, the researcher observed alterations in the wall construction of the balcony from the original facade design. Five alteration types are dominantly observed. look at fig 4.5. This is clear that it is an additional cost and compromise on façade design.

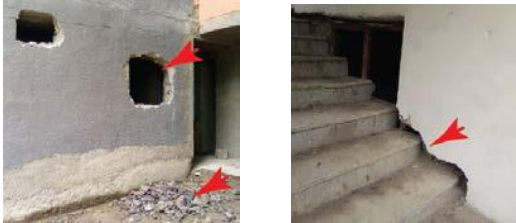
Fig 4.7 Rework wastage observed in sample sites

Reworks that don't comply with drawing and specifications is another issue in sample blocks. It is waste. Rework might be due to worker's mistakes, too. It may lead to structural failure. Look fig 4.7.

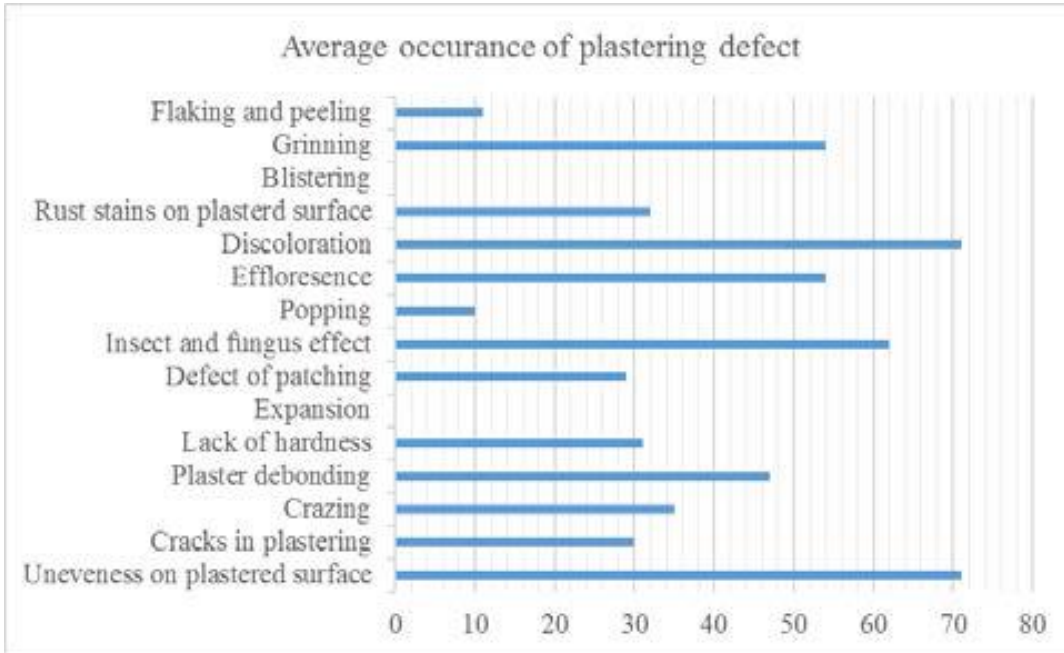
Fig. 4.9 Plastering defects frequency of occurrence on sample sites

The other and most important performance checkup done in the research is plastering defects. Some common defects of plastering on pumice concrete masonry work such as blistering, popping and expansion were found to be almost zero frequently in all the samples.

As we can see from the chart, from fifteen defects on plastering twelve are detected. The most dominating paltering defects are unevenness on plastered surface, insect and fungus effect, efflorescence, discoloration and grinning which count occurrence beyond fifty percent of overall

sample collected. Unevenness of plastering is due to unskilled workers. Labor-intensive nature of masonry work contributes to this defect type. Insect and fungus effect is the other dominating defect. It is the result of porous space in the work. Walling material with a high organic matter also encourages moss and mold growth.

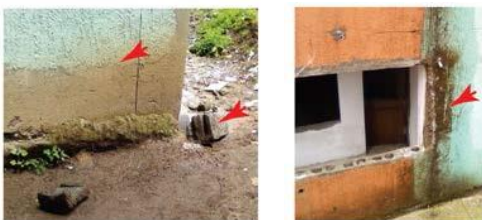
Fig. 4.10 Discoloration, Plaster debonding and fungus effect on masonry work

The discoloration is a change of applied coating as a result of weathering or human action. It is common to observe this problem in every sample site. Quartz-finished walls, especially ground-supported floors have this defect.

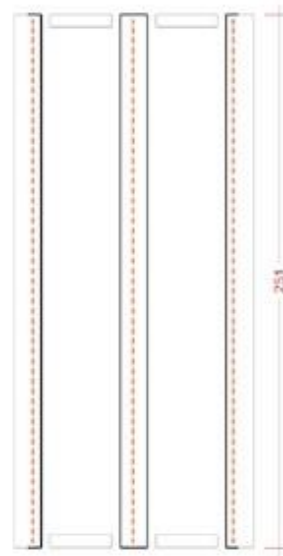
Figure 5-8 Mortar mix cement consumption variation from stretcher bond to studs between panels

Pattern of mortar bond

Conventional Block work

V.mortar = 66,560 c.m³

Mix design / ratio for mortar by volume = 1: 3 (cement to sand)

Cement = 16,640 c.m³ · Density of OPC cement = 1.44 g/c.m³

Mass of cement 23,961.6 g

Proposed panel

V.mortar = 38,654 c.m³

Cement = 9,664 c.m³ · Density of OPC cement = 1.44 g/c.m³

Mass of cement 13,917 g

↓ Binding material requirement Variation = 10,0445 c.m³
= 42 %

As the panel proposed is 2.51m by 0.5m, a comparison of pumice concrete and binding material requirement about the same height and width of stretcher bond of equivalent block work. It is found to be 49% pumice concrete and 42% binding material less required. The speed of installation is greatly improved. To construct 1.255m² (2.51m X

0.5 m) block work minimally requires 4 days. Independent panels can be installed within 2-3 hours. The panels also need one face of mortar plastering while the conventional system needs two faces.
